RESULTS OF THE
THIRD SATURN I LAUNCH VEHICLE
TEST FLIGHT

MPR-SAT-63-3

RESULTS OF THE THIRD SATURN I LAUNCH VEHICLE TEST FLIGHT

The results of the Saturn I SA-3 test flight are presented in this report which represents the early engineering evaluation. The performance of each major vehicle system is discussed with special emphasis on malfunctions and deviations.

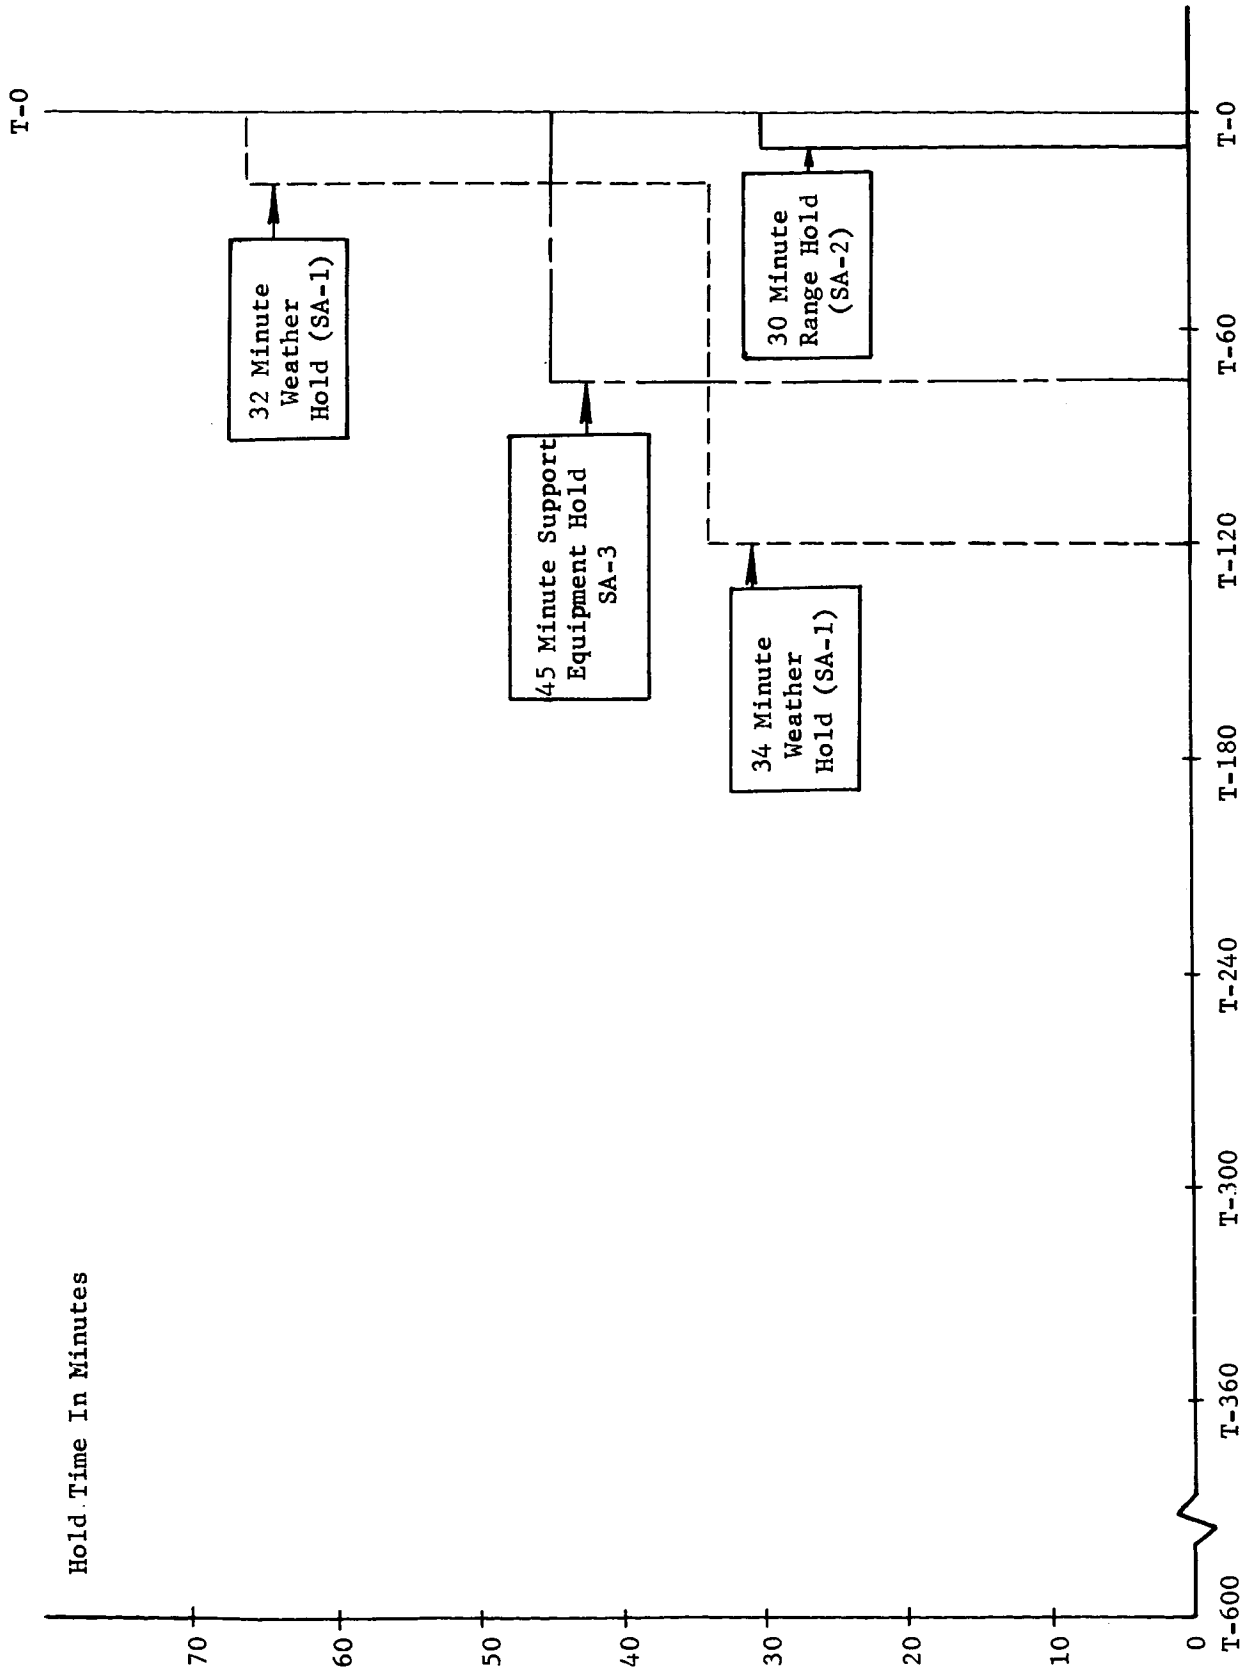
FIGURE 2. COUNTDOWN TIME IN MINUTES

Holds. Launch countdown began at T-600 minutes at 0200 EST on November 16, 1962 and was continuous except for one 45-minute hold caused by ground generator power failure at T-75 minutes (Figure 2). Network generator number 2 dropped out, apparently due to the over-voltage sensing circuit, causing the hold. The nominal value for activation of the over-voltage device is 37 volts; however, it was found that the over-voltage sensing device for this generator had shifted to 35 volts (approximately the terminal voltage of the generator at the moment of dropout). The sensing device was replaced. The over-voltage bypass circuit for all generators (normally energized at "LOX bubbling complete") were then jumpered for the remainder of the countdown to avoid further difficulties in this area. The count was resumed at 1130 hours EST and continued until launch.

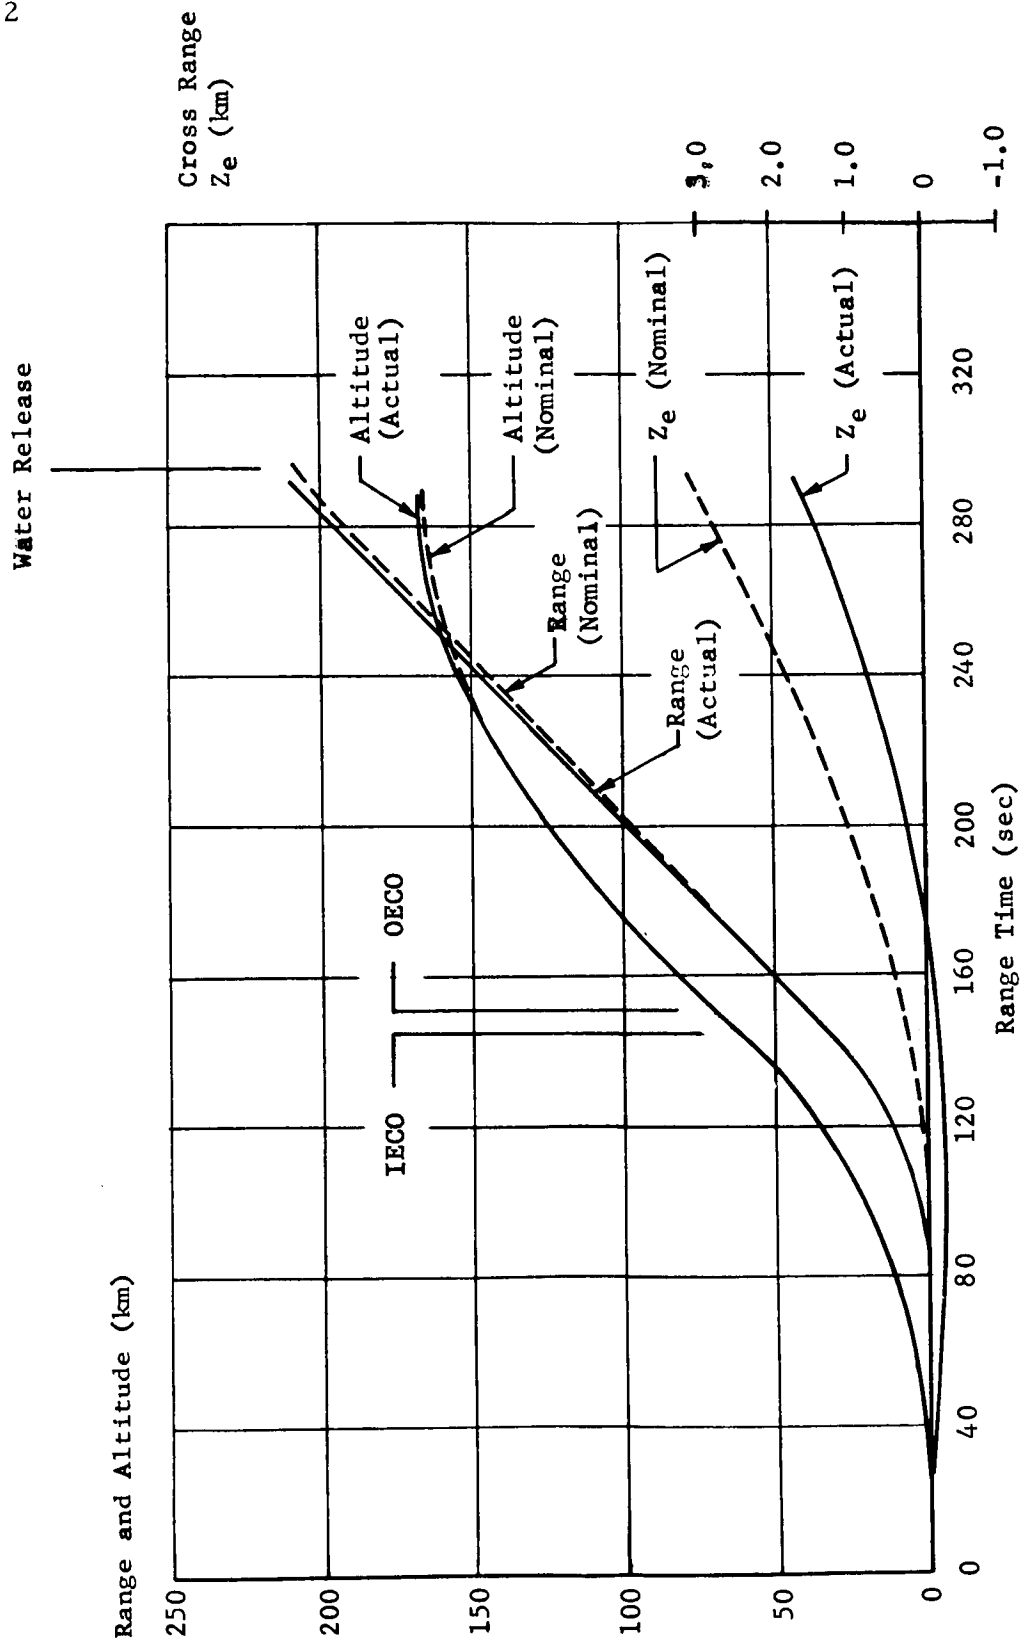
FIGURE 13. TRAJECTORY

Water release occurred at 292.0 sec range time. The vehicle was 0.45 km higher and 3.76 km further in range than was expected.

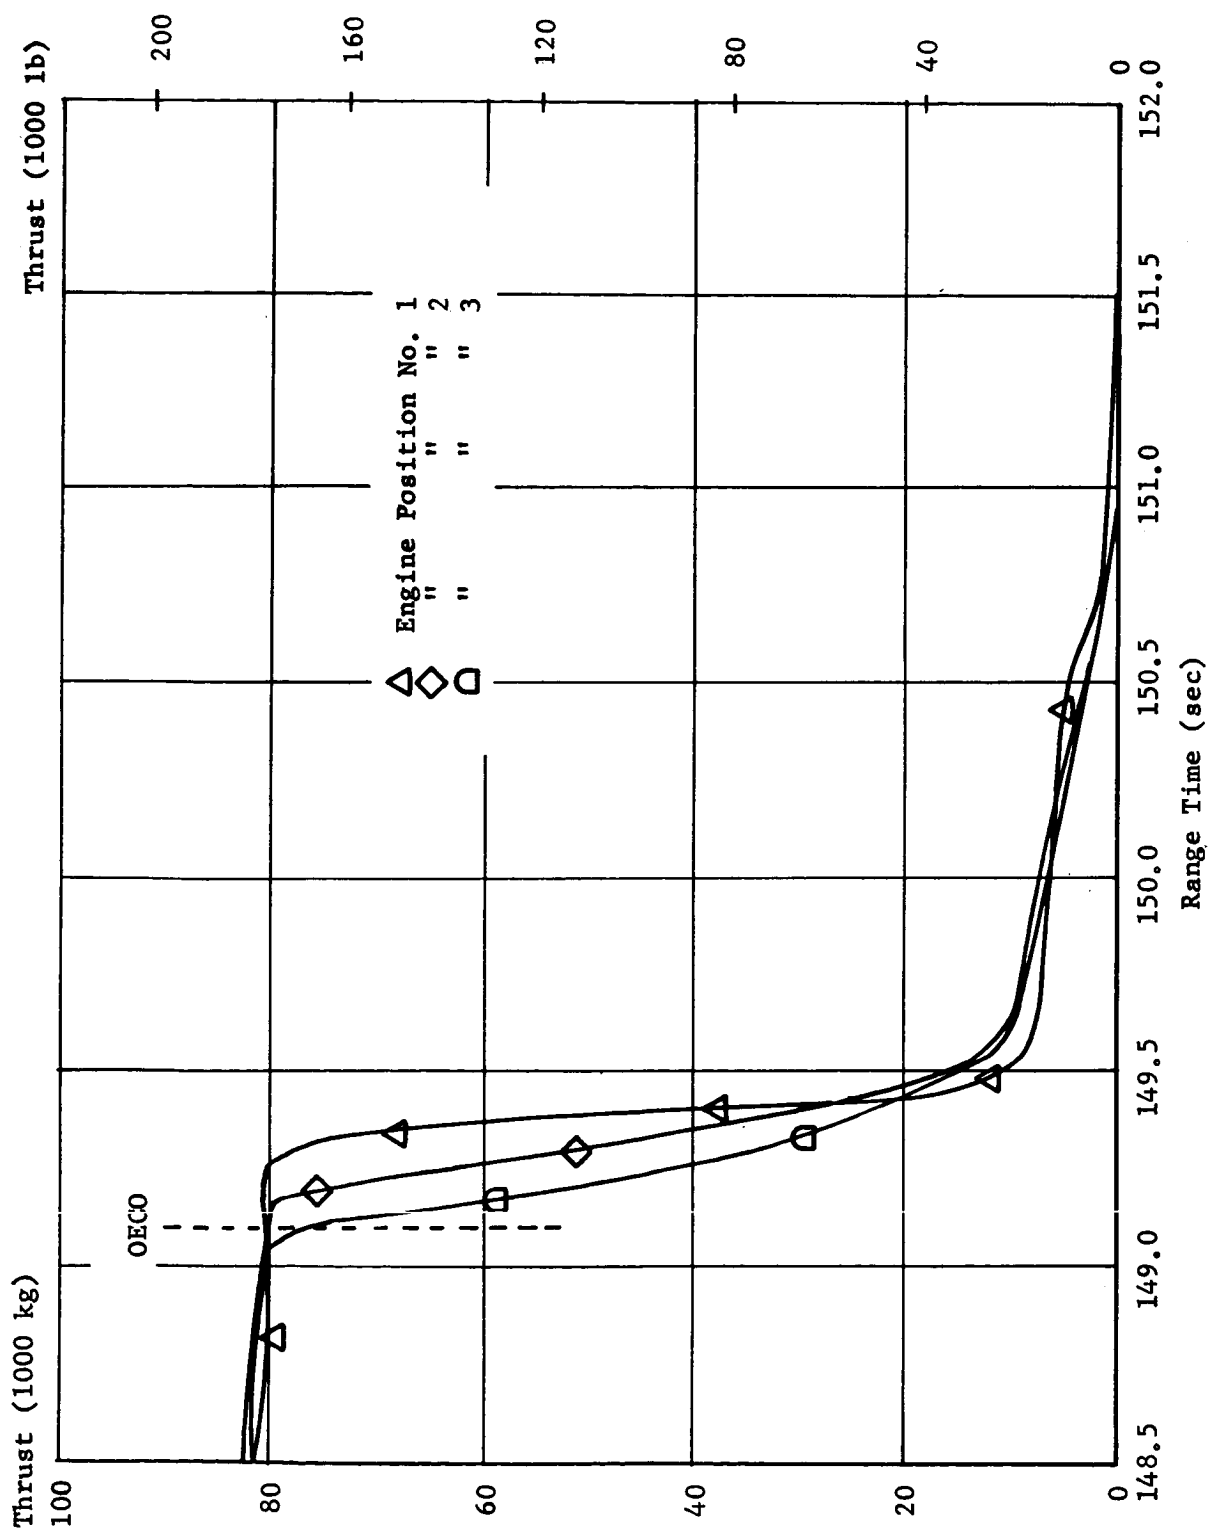
FIGURE 8. OUTBOARD ENGINE THRUST DECAY

Thrust Decay. The actual velocity gain during outboard engine thrust decay was 7.9 m/s and the nominal velocity gain was 7.6 m/s. A comparison of the two has no significance since LOX depletion occurred.

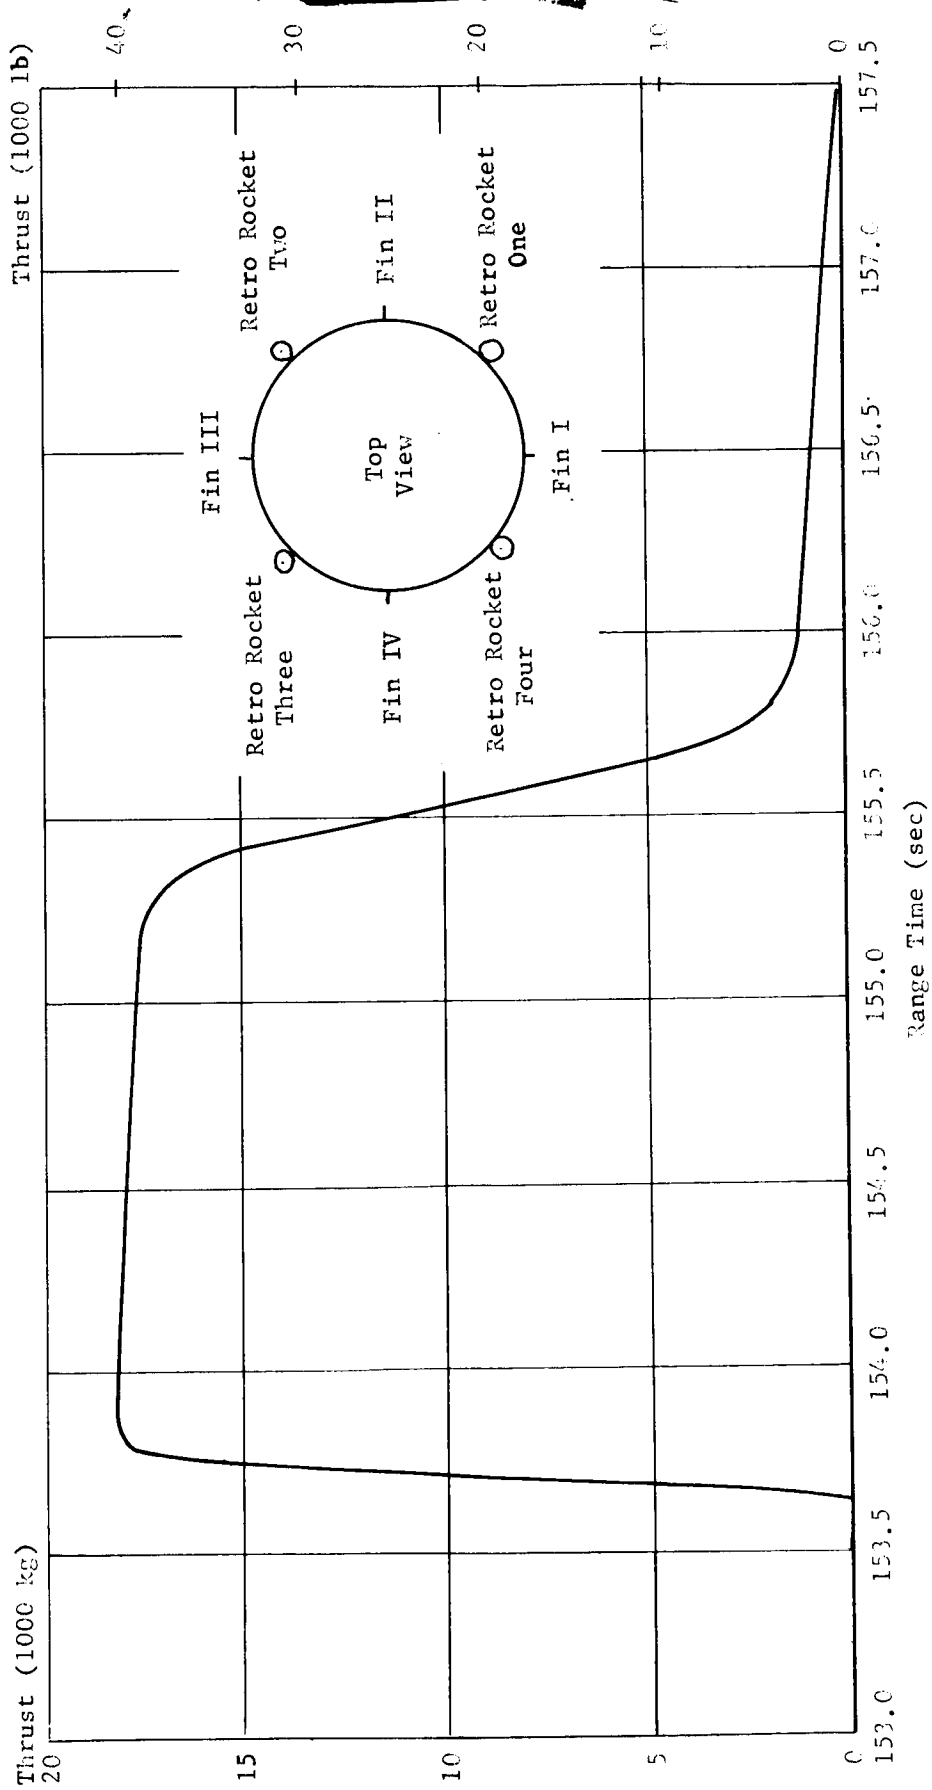
FIGURE 11. TYPICAL RETRO ROCKET CHAMBER THRUST

A typical retro rocket thrust curve is shown in Figure 11. Telemetered retro rocket chamber pressure data indicated satisfactory retro rocket performance and approximately equal performance levels for the four retro rockets. The performance of the retro rockets was within expected limits of the predicted,

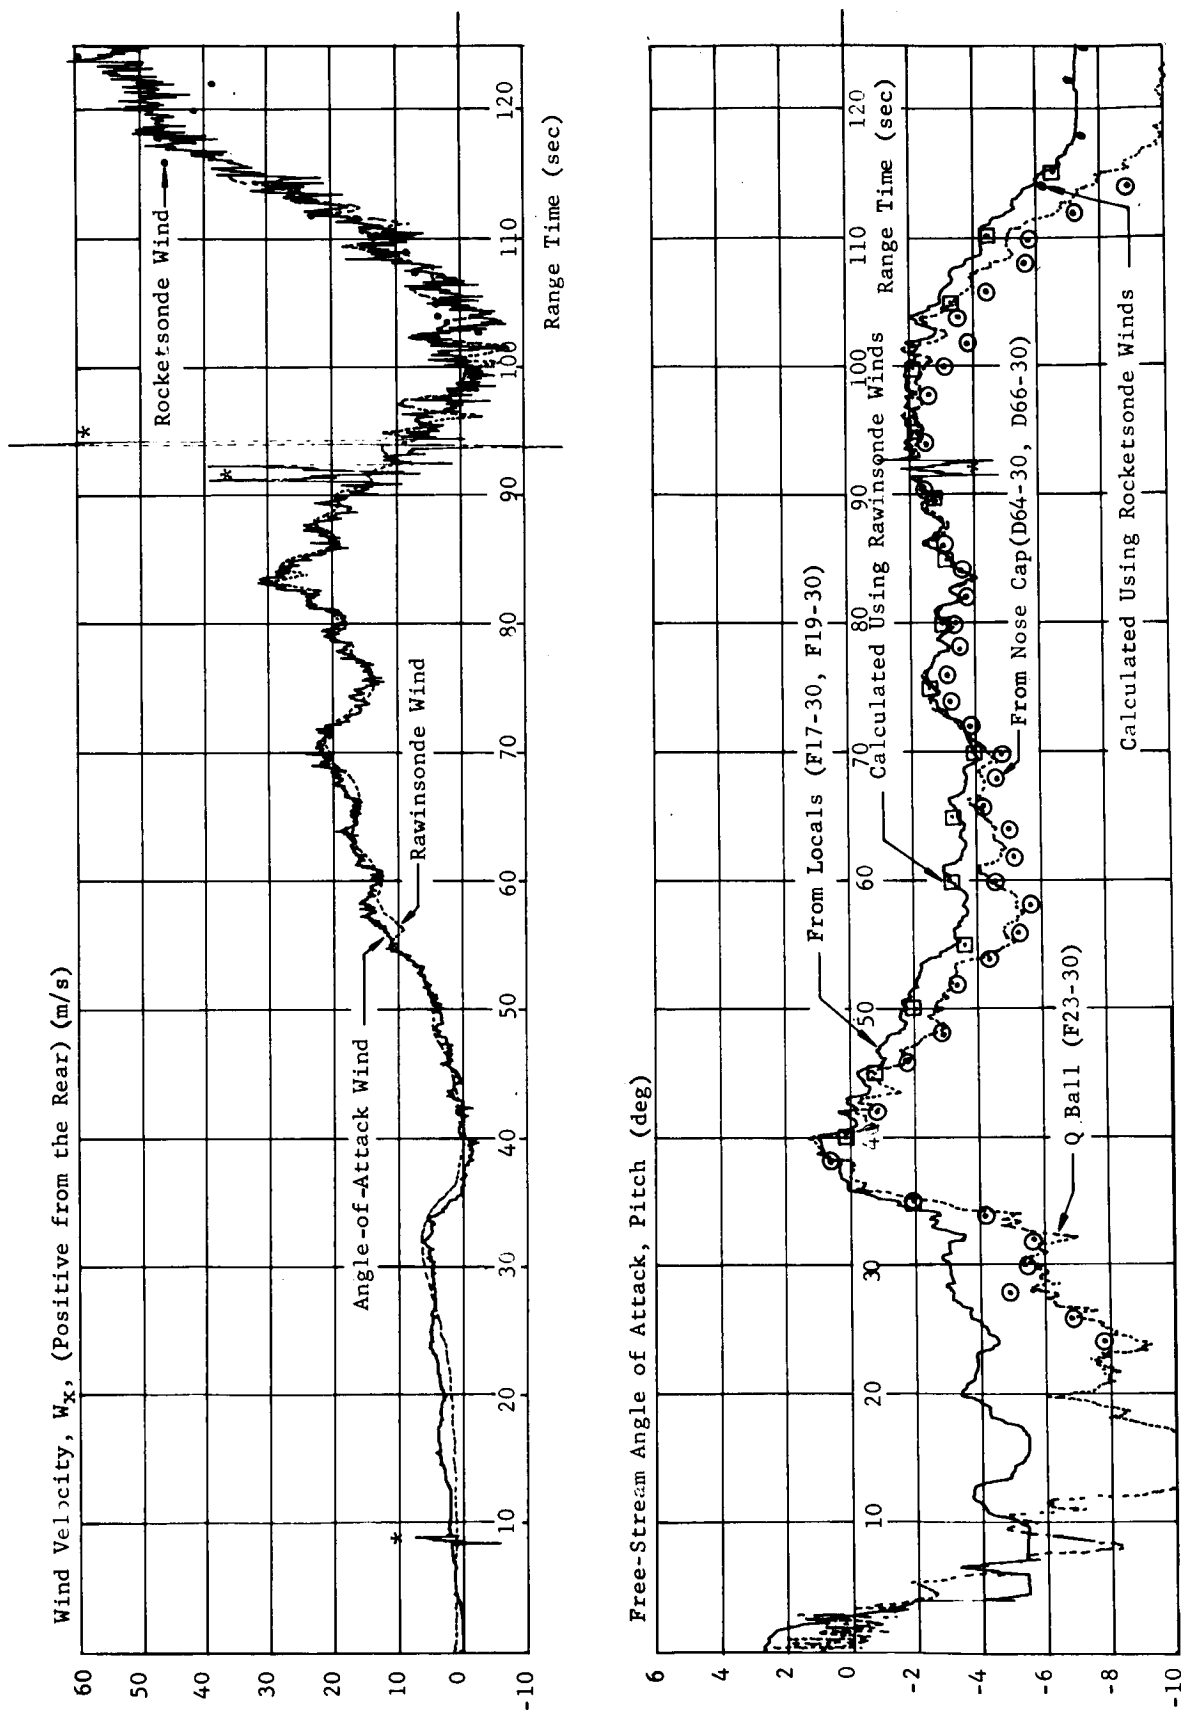
Shown in Figure 15 is a comparison of the pitch component winds as a function of time from three sources; rawinsonde, rocketsonde, and angle-of-attack winds. The angle-of-attack winds (solid line) were determined from attitude and angle-of-attack measurements made onboard the vehicle which were

FIGURE 15. PITCH PLANE WIND COMPONENT AND FREE-STREAM ANGLE-OF-ATTACK

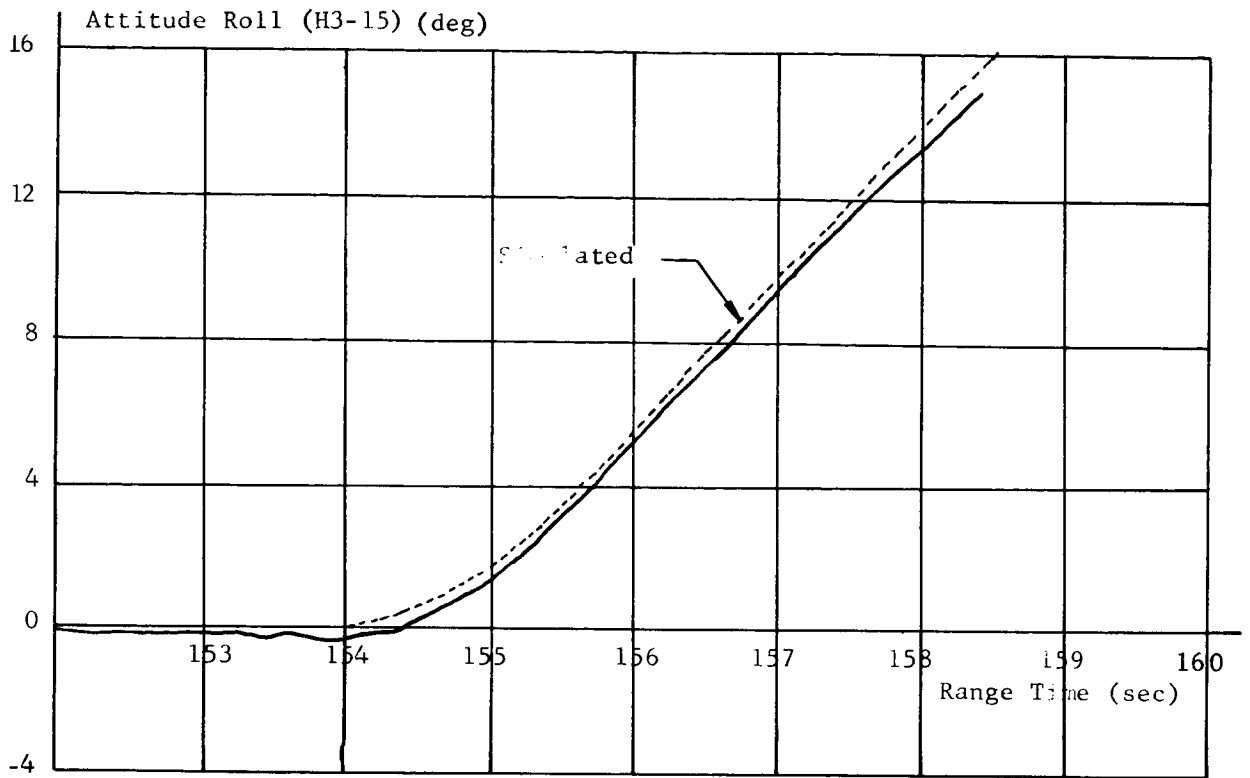
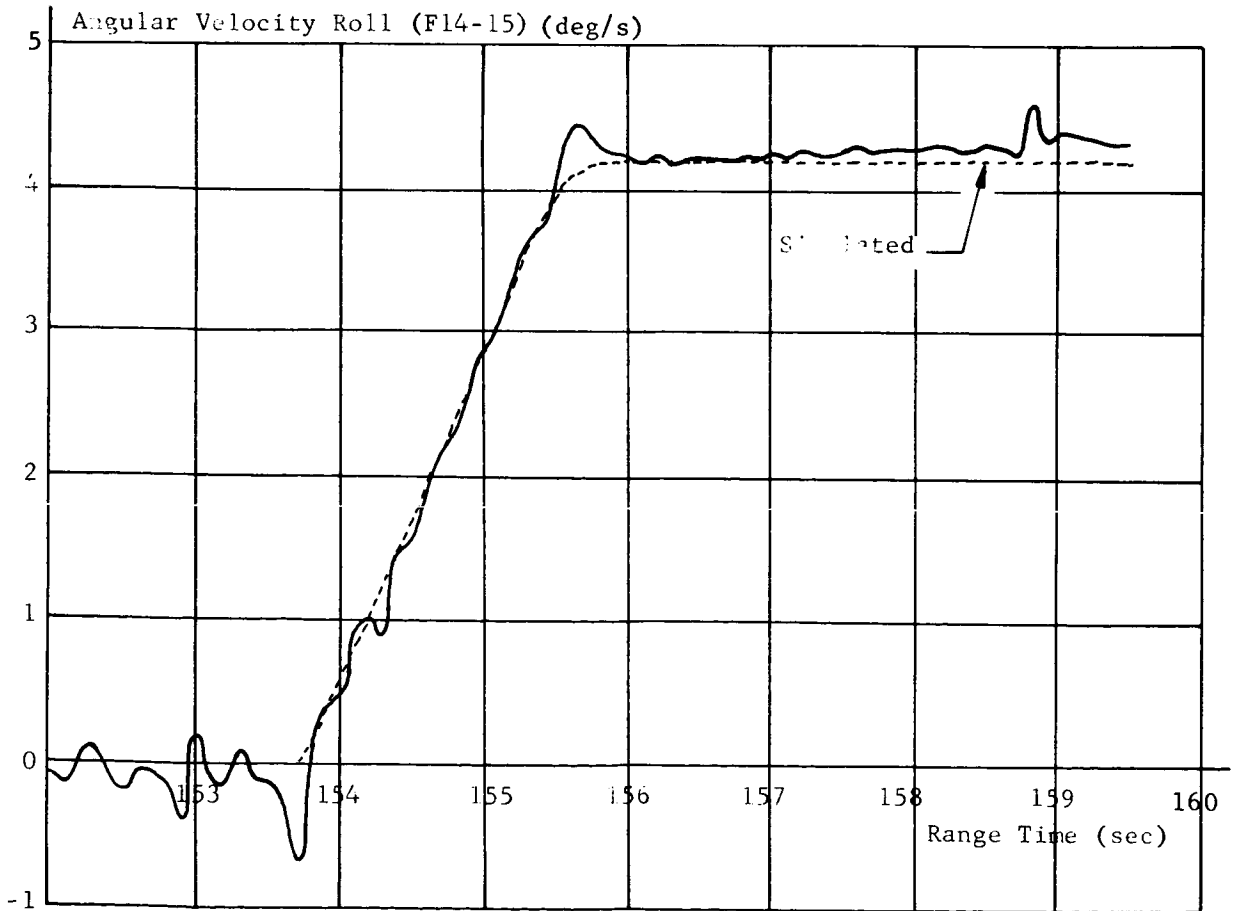
questionable. However, there is a possibility that the LOX stud became a load path at retro ignition, and since the LOX studs are 3.8 inches off of the spider beam centerline an effective misalignment would result from twisting of the spider beam outside of the cross beam network. The results would be in the same direction as that observed from telemetered data.

FIGURE-21. ROLL DURING RETRO ROCKET FIRING

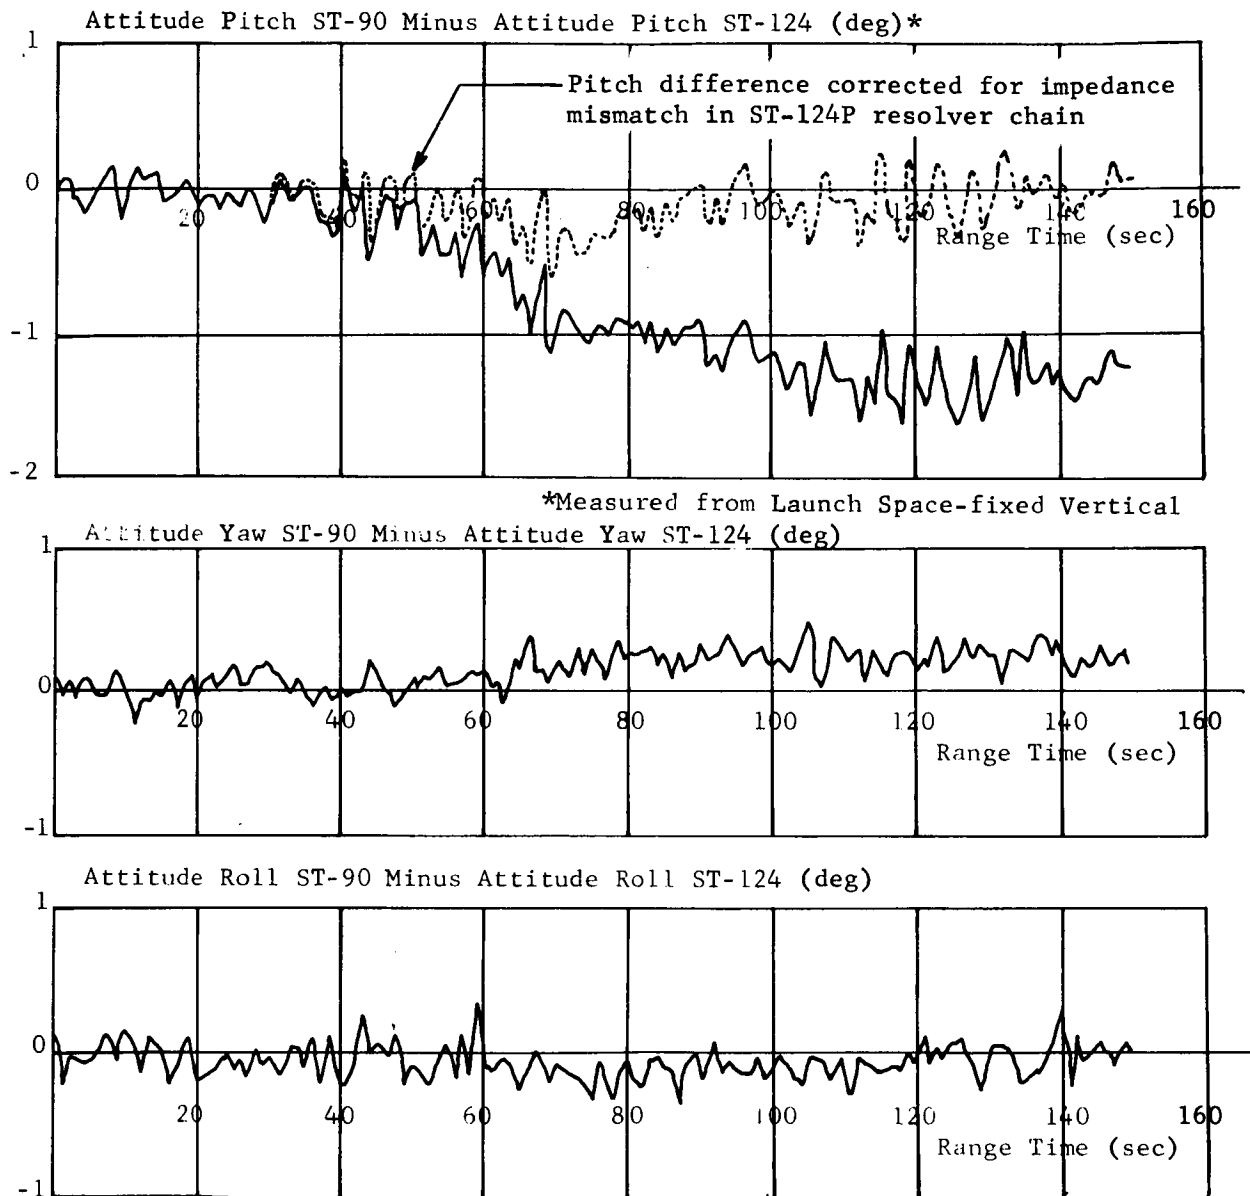
A comparison of the attitude measurements from the two platforms (ST-90 and ST-124P) shows some difference in all three axes (Figure 27). The systematic deviation, shown between the yaw and roll attitude measurements from the two platforms, is due to the misalignment of the ST-124P platform azimuth reacting, through the vehicle tilting, as mentioned in Section VIII C.3. The additional small differences are felt to be due to excess backlash in the servo gear trains in the ST-124P and telemetry and data reduction errors. The much larger systematic difference between the pitch attitude angles is due to an impedance mismatch in the ST-124P resolver chain. This pitch angular error (ϕ_e) is a function of the impedance mismatch and the sine of twice the resolved angle (i.e. $\phi_e = -M \sin 2\chi$). χ is the tilt angle of the ST-124P outer pitch

FIGURE 27. -- ATTITUDE DIFFERENCES BETWEEN ST-90 AND ST-124P

resolver. The dashed line in Figure 27 shows the remaining difference in the pitch angles after a correction for a 1.3 Ω (approximately 0.3 percent) impedance mismatch error has been made.

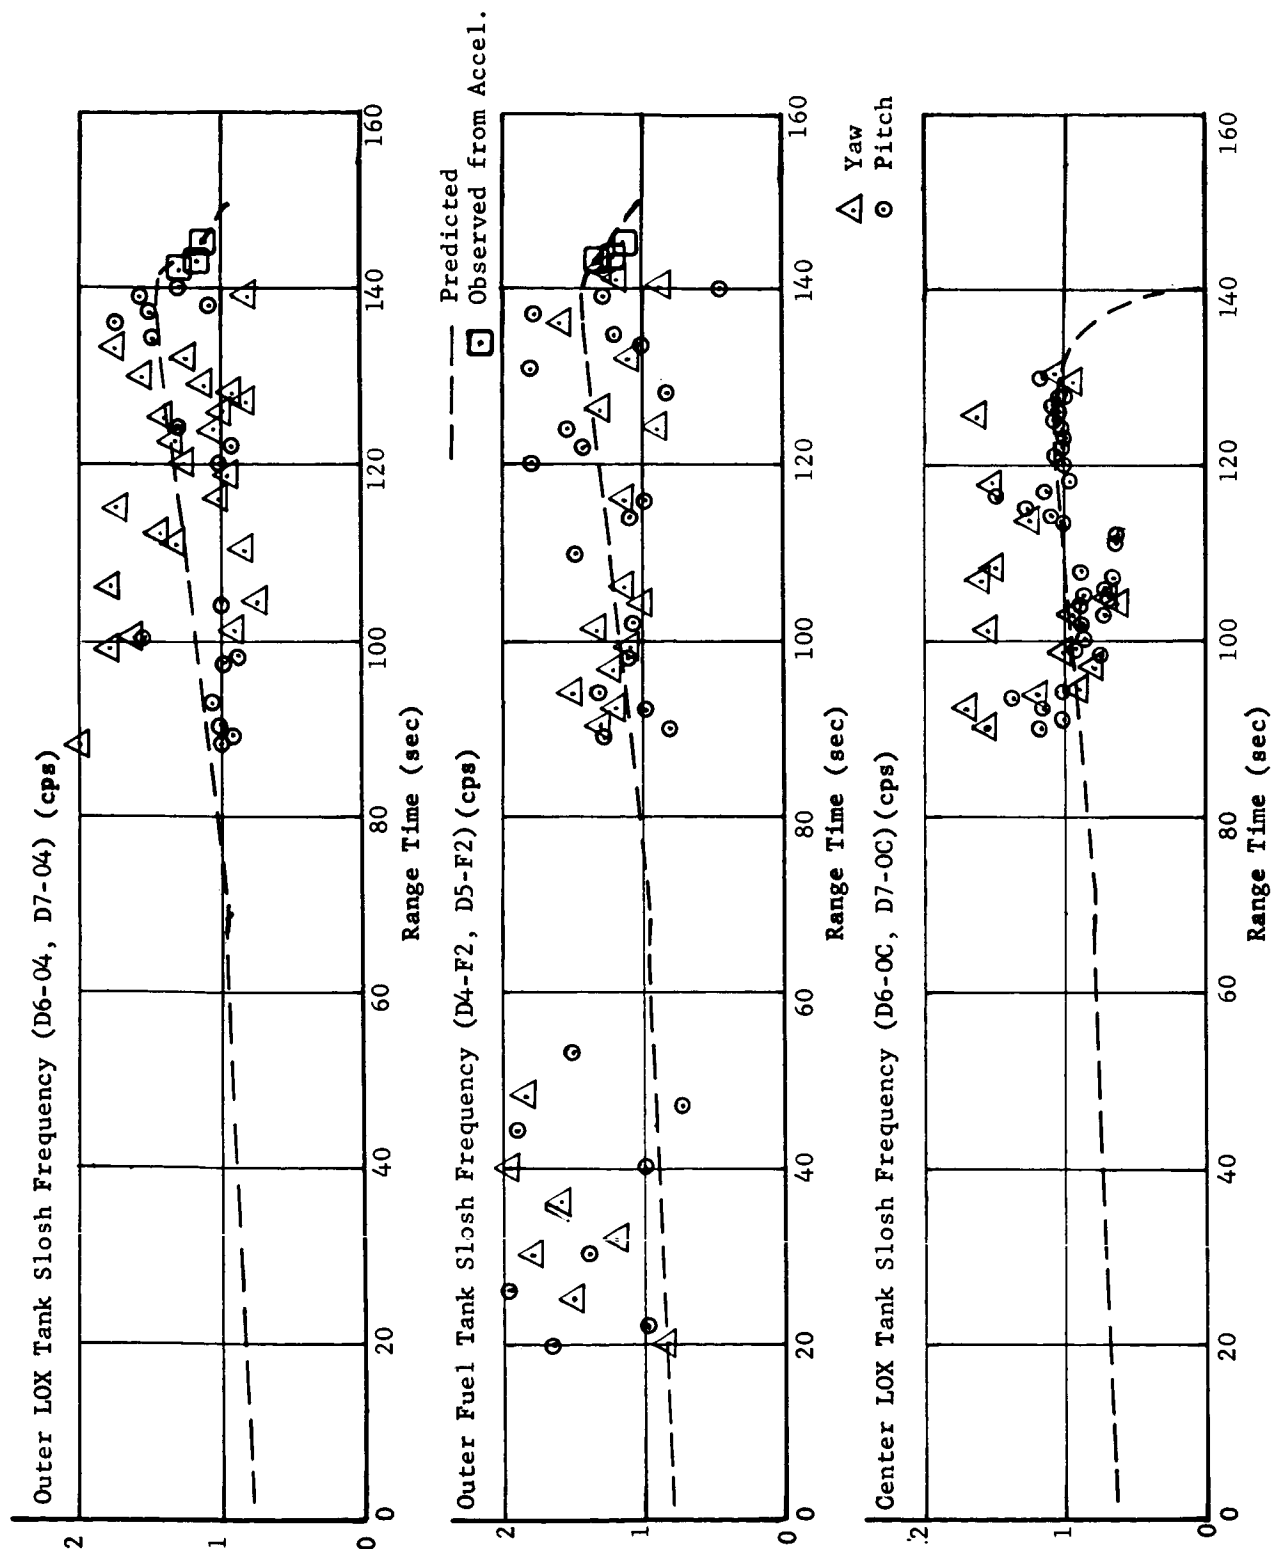
Figure 29 shows a comparison of some of the frequencies detected in the sloshing measurements compared to the predicted. The square points shown after IECO are frequencies detected in some of the accelerometers, which indicate that the vehicle was being forced by the sloshing. The pitch actuator positions also indicated this. In this case, in contrast to SA-1, the vehicle appears to be driven at the natural frequency of the propellant, rather than at some coupled frequency. Whether this is consistent or not is not known at this time.

FIGURE 29. SLOSHING FREQUENCIES

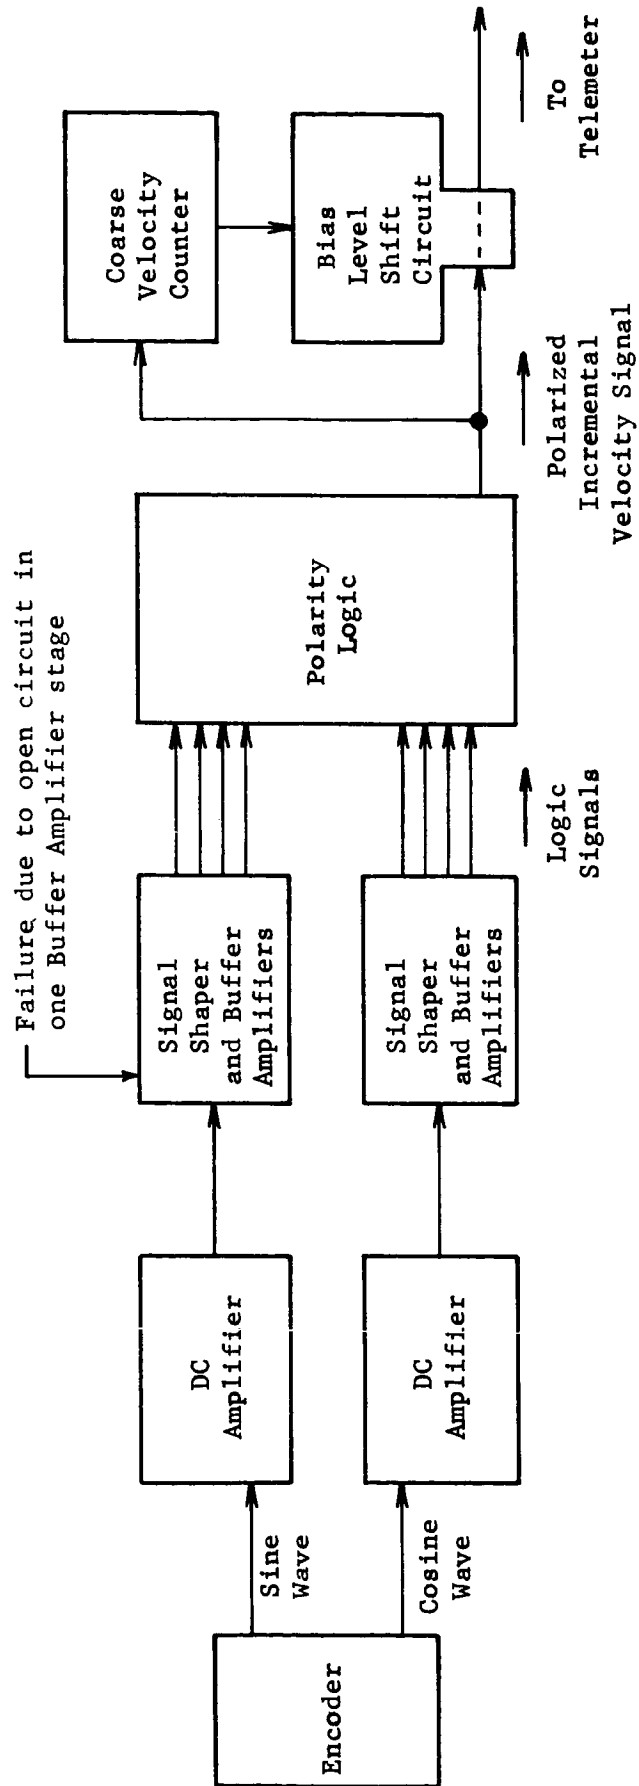
FIGURE -34. SIMPLIFIED SCHEMATIC OF CROSS RANGE SIGNAL PROCESSOR

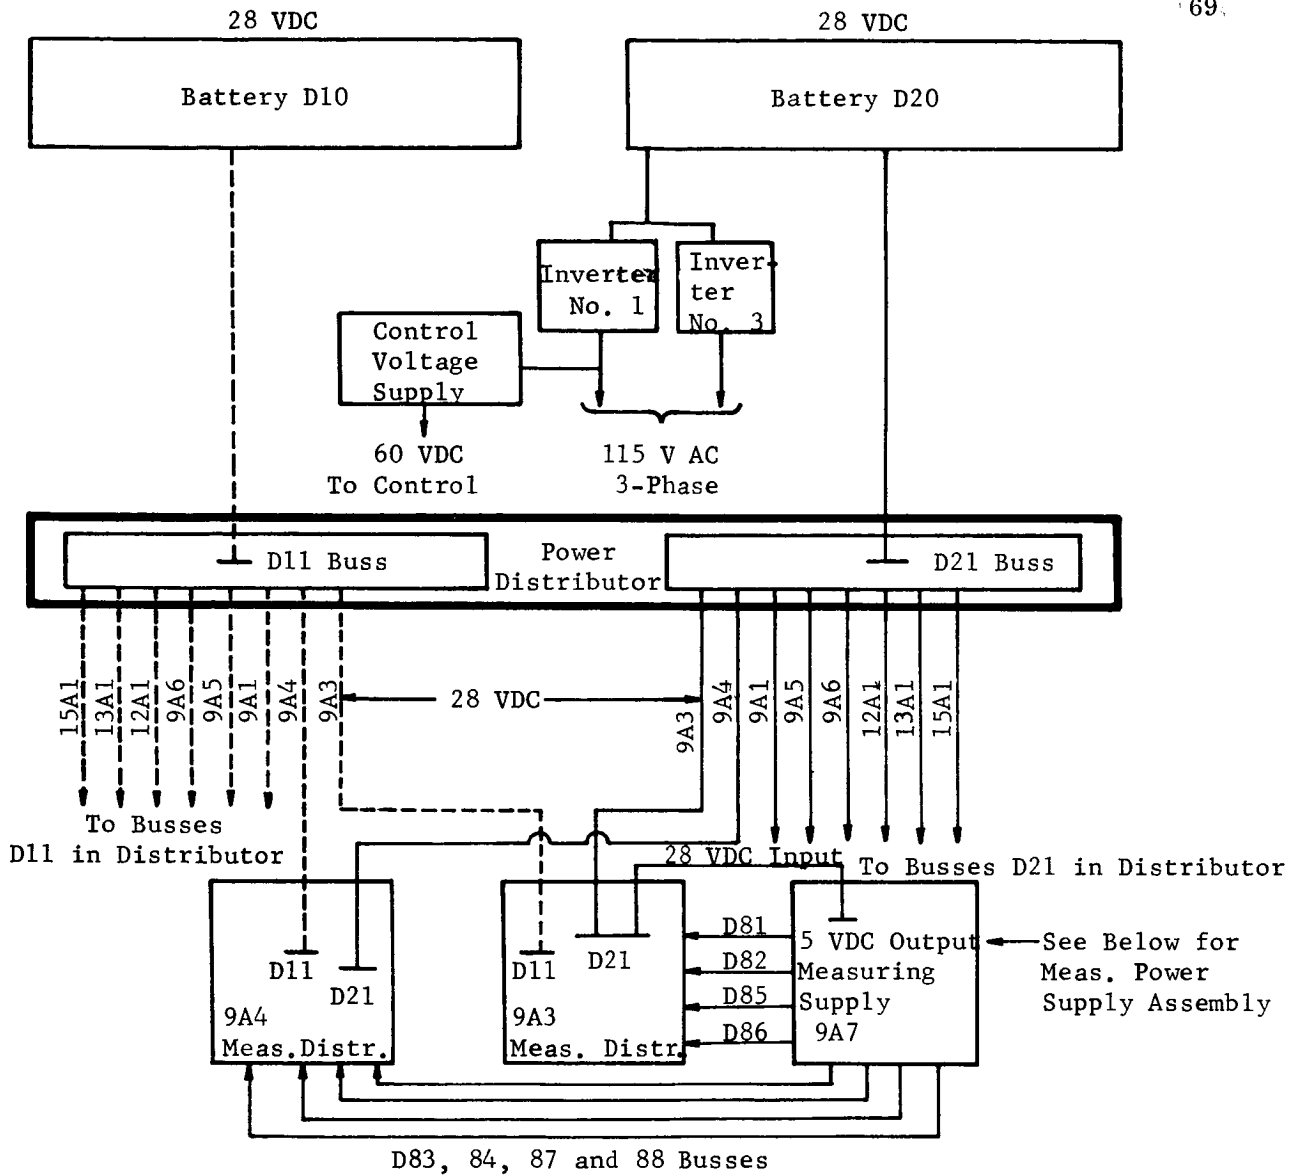
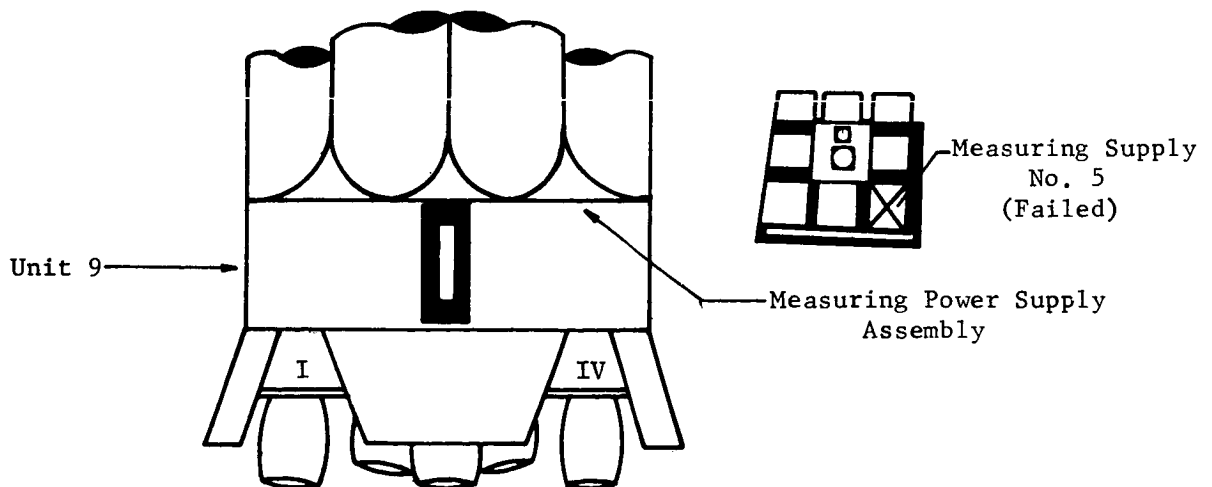
FIGURE 35. DISTRIBUTOR CONNECTIONS AND UNIT 9 MEASURING SUPPLY

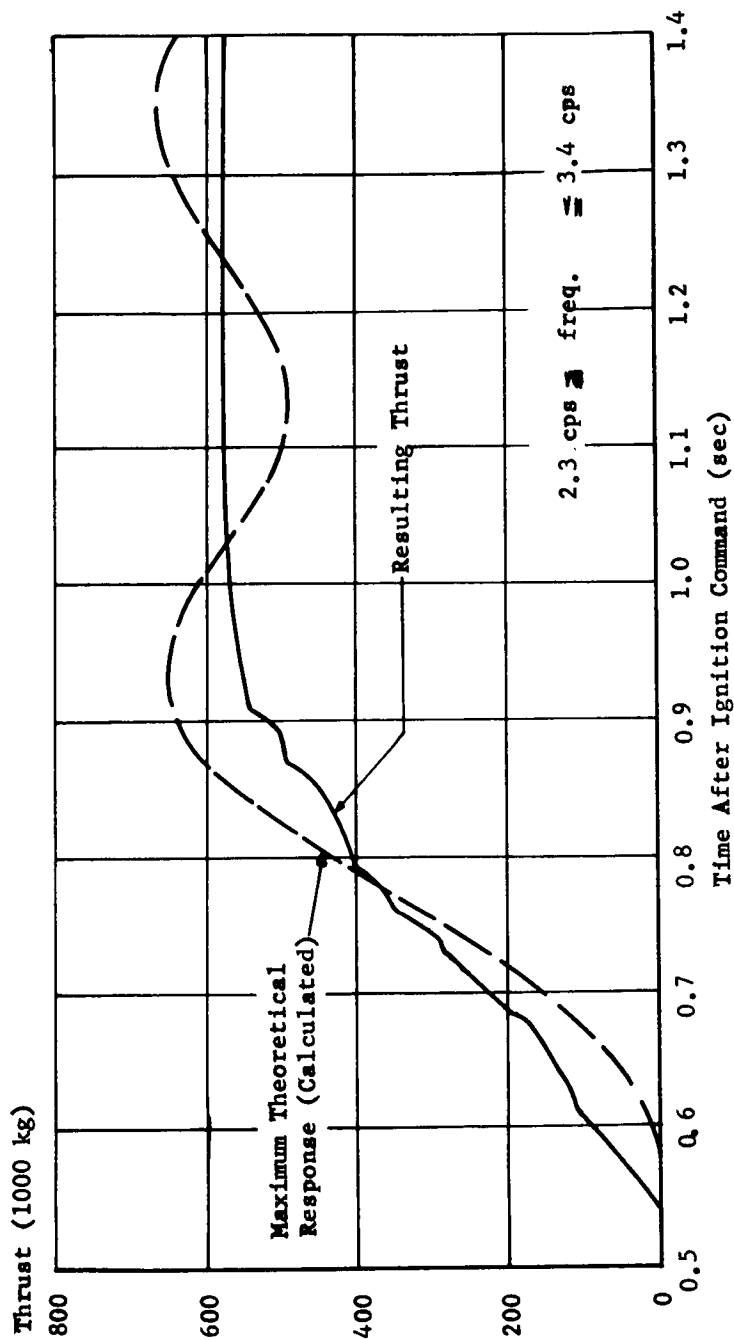
FIGURE 39. MAXIMUM DYNAMIC RESPONSE

measurements and from single engine thrust curves, the maximum vibrating force was obtained as shown by the maximum theoretical response (calculated) on Figure 39. These results show that the maximum response was sixteen percent of the maximum static thrust.

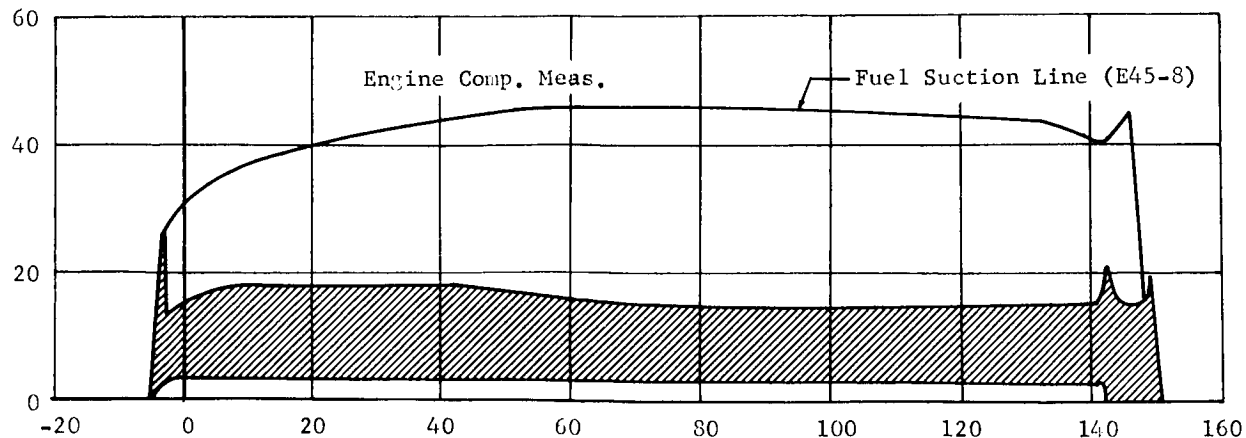
The upper part of Figure 44 displays maximum and minimum acceleration time histories of the structural measurements. The upper portion of the envelope was established by the data from the gimbal point support measurements and heat shield measurement, which were previously noted to have remained constant throughout flight. The lower portion of the envelope, characterized by the spider beam measurements, shows an increase in vibration level in the region of Mach 1 and q max.

FIGURE 44. VIBRATION ENVELOPE OF STRUCTURE,
CANISTER AND ENGINE COMPARTMENT MEASUREMENTS

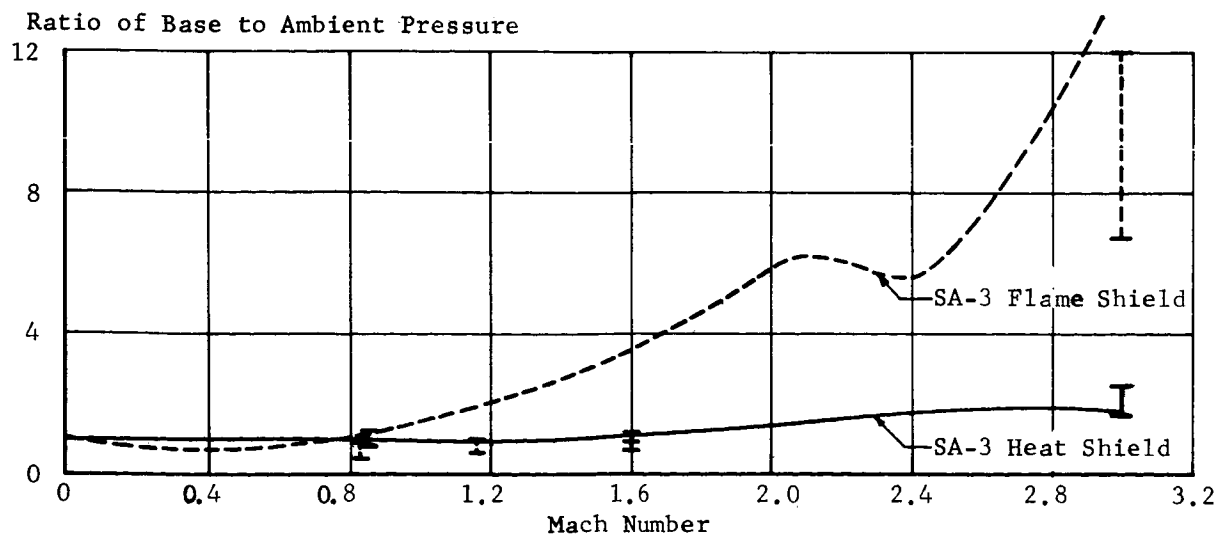
Average values of the ratio of base to ambient pressure, p_b/p_a , for both the heat shield and flame shield (center star) are plotted versus Mach number in Figure 48. Wind tunnel test data from the Rocket Test Facility, AEDC, are also shown for comparison.

FIGURE 48. RATIOS OF BASE PRESSURE TO AMBIENT PRESSURE VERSUS MACH NUMBER
